Liawenee Flume Project

Warren Environmental, Inc.

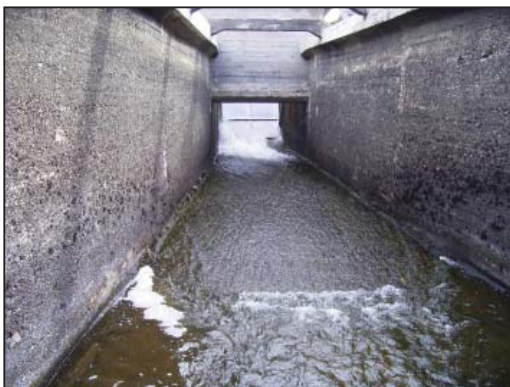
The flume was a cast-in-place concrete 'U' section with 10-ft walls and a 12-ft base. The surface was significantly eroded by the water flow and freeze thaw damage. In some places the rebar was showing. The surface was extremely coarse being an exposed Dolerite aggregate, very sharp and very hard. There was significant moss growth that would have to be removed.

Flume before work commenced.

At site we unloaded the preparation equipment and set about removing the moss, growths and unsound areas from the surface with a high-pressure jet washer and in more difficult areas with a pneumatic scabber. For the next stage we sprayed the whole area to be coated with a dilute bleach as a mild biocide

and thoroughly washed down with copious amounts of water. We followed this with a dilute acid wash to remove carbonates and calcium deposits in the concrete surface. This was again followed by a thorough wash down with water.

At Liawenee, the actual coating was in two stages. We prepared and coated the walls first and then de watered the base and coated it last. The first coat of Ultracoat was sprayed on and then floated off with large trowels and scrapers to force the resin into the very coarse surface to fill out any voids and give a smooth ceramic like surface ready for the next coat.

The second coat was applied and also struck off using floats to produce a very glossy smooth finish to optimize water flow and hence the efficiency of the flume.

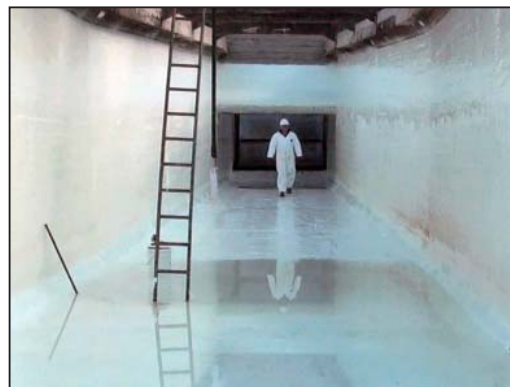
The end result was a glossy and very durable surface completed in double quick time; we now await the results of the flow testing.

Completed job, a very durable glossy finish.
